Inlet Bay Apartments Project

POLY FOAM GROUND IMPROVEMENT PROJECT

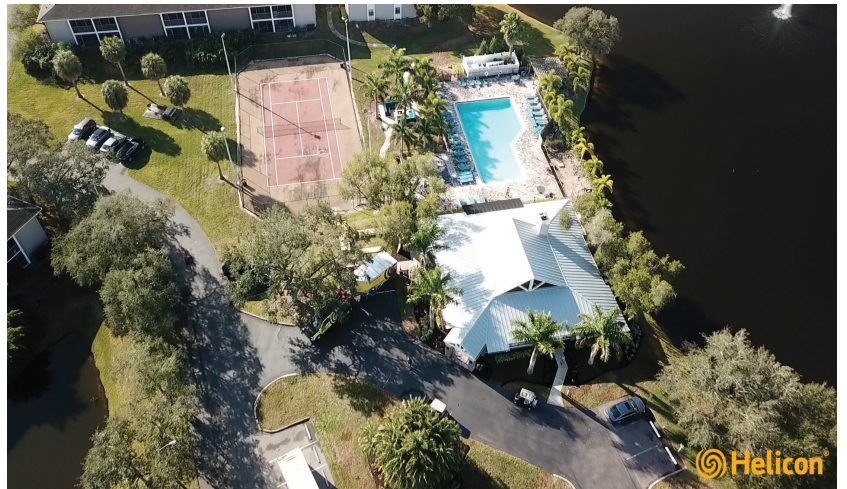
- Soil conditions with large voids underneath pool deck

The voids underneath the pool deck were discovered when the apartment complex owners replaced a wood deck that was attached to the brick paver pool deck. When the old wood deck was removed, the voids were obviously a hazard, that is when Helicon was contacted to remedy the situation. The poly foam was injected underneath the pool deck to fill large voids that could have compromised the integrity of the entire pool deck.

Over 1,200 lbs of poly foam was injected underneath the pool deck during the course of this project. The poly foam was documented to have sufficient uplift resistance capacity and provides the necessary support for the pool deck area. All work was completed in a timely manner and the apartment complex owners were able to continue building their attached wood deck immediately thereafter.
